**Flood Control Project Maintenance  
Levee Inspections**

**Fall 2008 Levee Maintenance Deficiency Summary Report**

**Reclamation District No. 2063**

Waterway	Bank	Unit Miles
Unit No. 01 San Joaquin River	Right	10.60

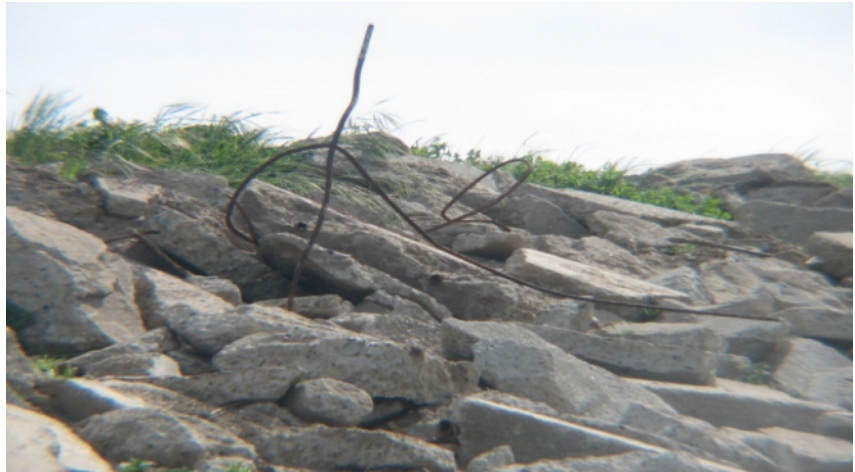
Levee Mile Report Line	3
Start Levee Mile	0.59
End Levee Mile	0.60
Location	
Category	Earthen Levee
Item	Encroachments
Concrete rubble with rebar from LM 0.59 to 0.60

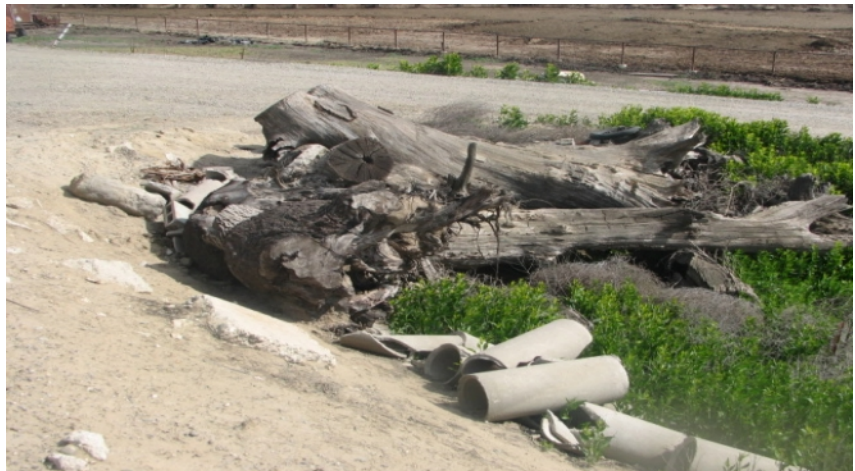
Levee Mile Report Line	7
Start Levee Mile	1.89
End Levee Mile	1.89
Location	
Category	Earthen Levee
Item	Encroachments
Concrete and tree stumps on landside slope at LM 1.89

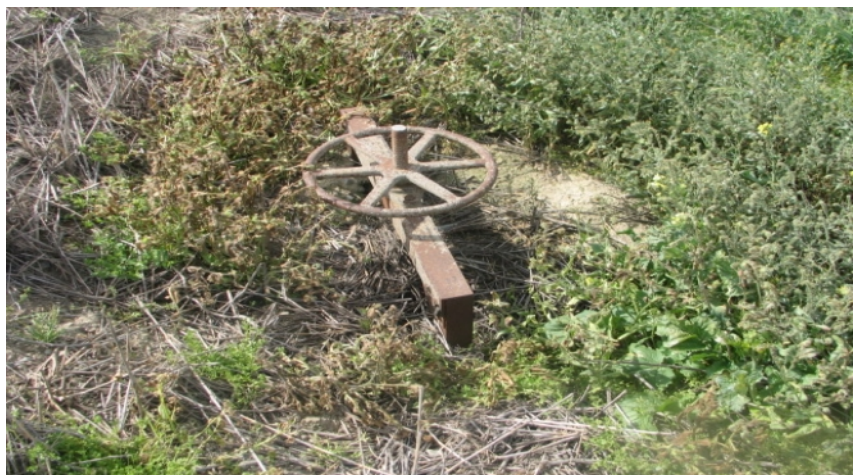
Levee Mile Report Line	8
Start Levee Mile	1.92
End Levee Mile	1.92
Location	
Category	Interior Drainage & Piping Systems
Item	Sluice / Slide Gates
Screw gate buried on landside slope at LM 1.92

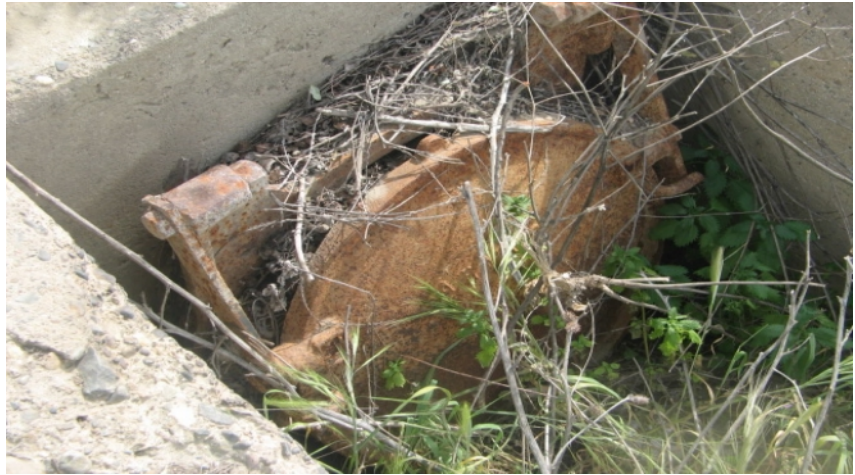
Levee Mile Report Line	13
Start Levee Mile	2.66
End Levee Mile	2.66
Location	
Category	Interior Drainage & Piping Systems
Item	Flap Gates
Flap gate blocked at LM 2.66

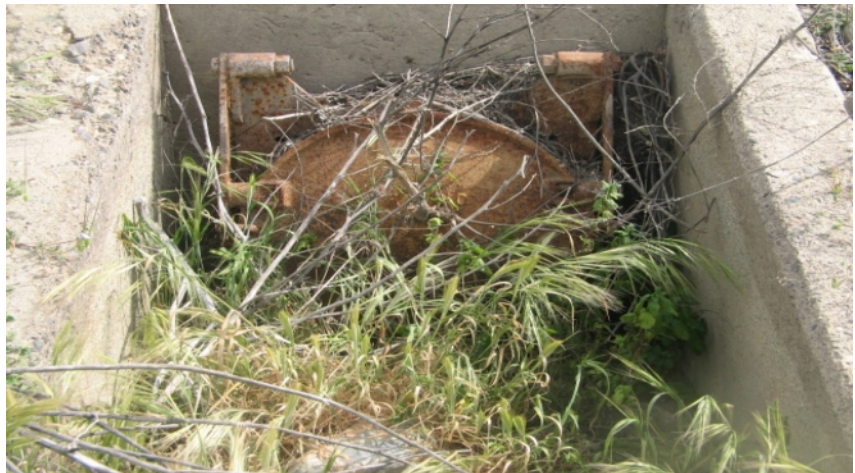
Levee Mile Report Line	13
Start Levee Mile	2.66
End Levee Mile	2.66
Location	
Category	Interior Drainage & Piping Systems
Item	Flap Gates
Front view of blocked flap gate at LM 2.62

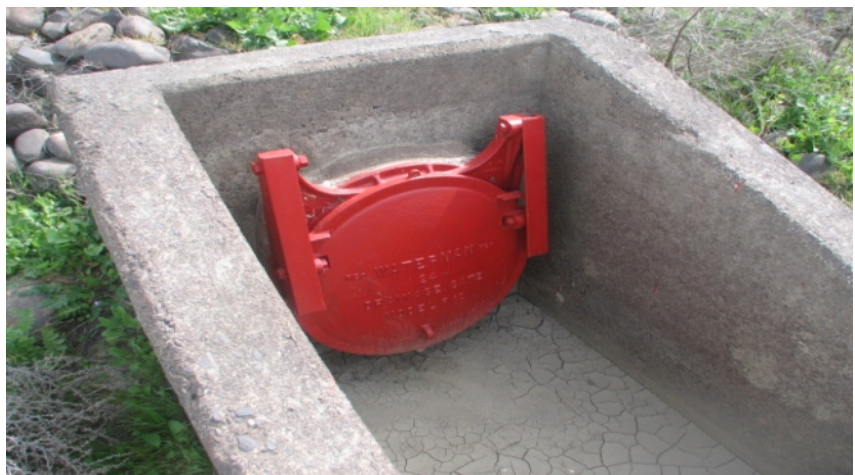
Levee Mile Report Line	15
Start Levee Mile	2.72
End Levee Mile	2.72
Location	
Category	Interior Drainage & Piping Systems
Item	Flap Gates
Acceptable flap gate at LM 2.72 on 03/27/08

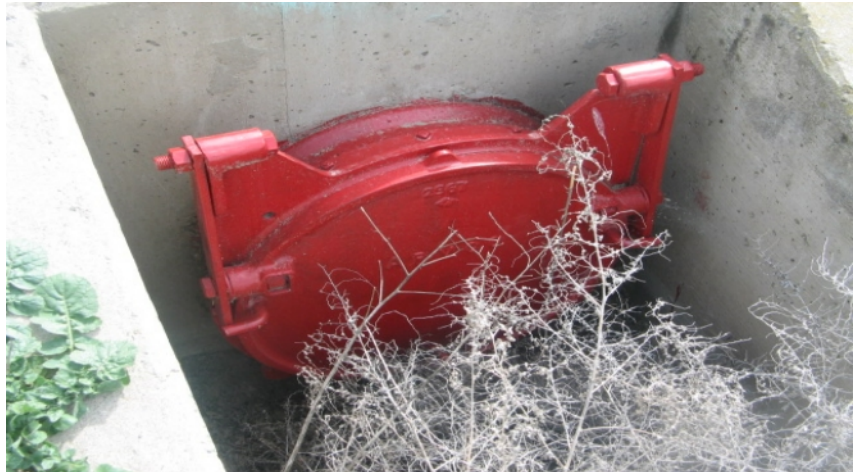
Levee Mile Report Line	16
Start Levee Mile	2.98
End Levee Mile	2.98
Location	
Category	Interior Drainage & Piping Systems
Item	Flap Gates
Acceptable flap gate at LM 2.98 on 03/27/08

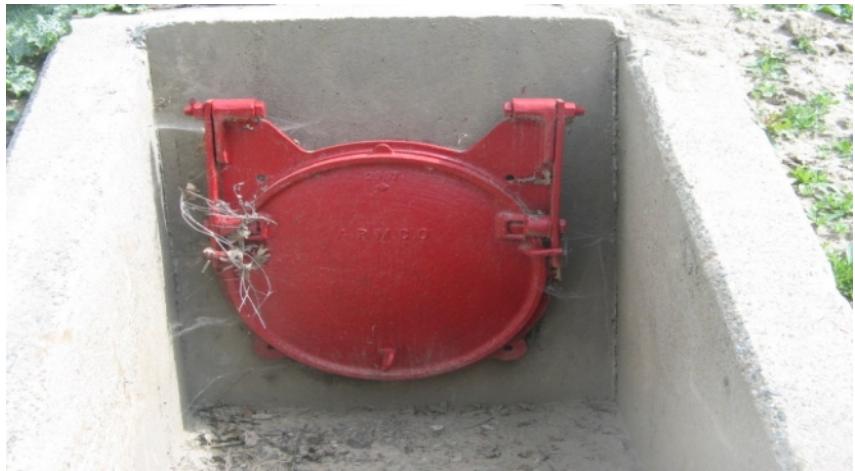
Levee Mile Report Line	17
Start Levee Mile	3.34
End Levee Mile	3.34
Location	
Category	Interior Drainage & Piping Systems
Item	Flap Gates
Acceptable flap gate at LM 3.34 on 03/27/08

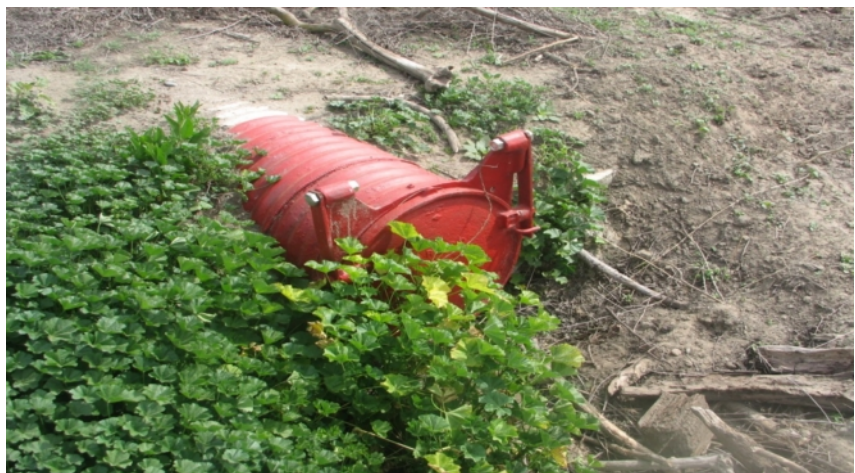
Levee Mile Report Line	18
Start Levee Mile	3.69
End Levee Mile	3.69
Location	
Category	Interior Drainage & Piping Systems
Item	Flap Gates
Acceptable flap gate at LM 3.69 on 03/27/08

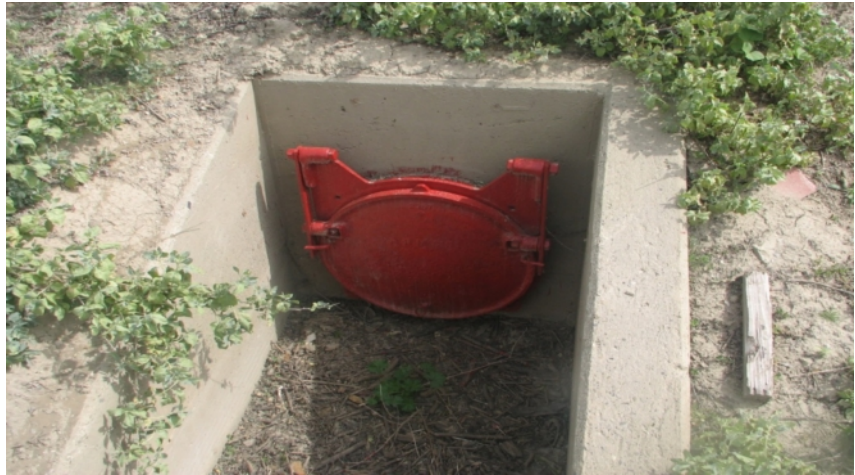
Levee Mile Report Line	23
Start Levee Mile	4.08
End Levee Mile	4.08
Location	
Category	Interior Drainage & Piping Systems
Item	Flap Gates
Acceptable flap gate at LM 4.08 on 03/27/08

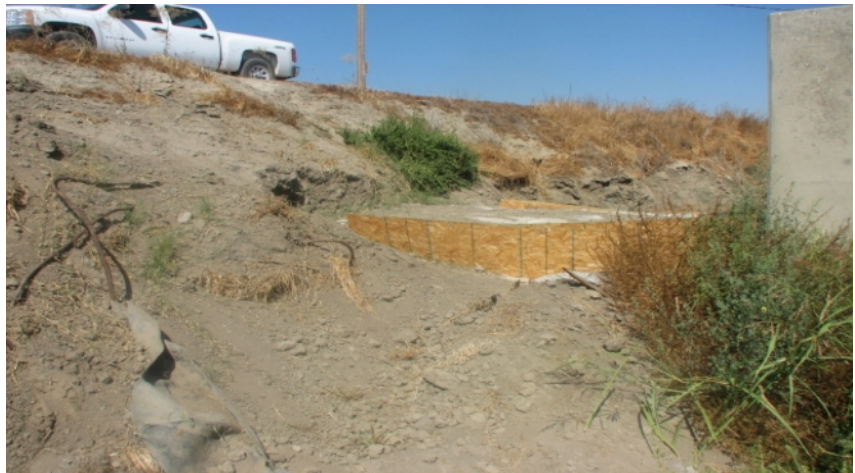
27	4.70	4.90	Earthen Levee	Vegetation	LS	M	Remove the wild growth other than native grasses from the levee slopes.	37.429793 ° -121.005037 °	37.429775 ° -121.001567 °		33
28	5.13	5.13	Earthen Levee	Encroachments	LS	U	Pipe Inspector Comments: Landowner modify pipe structure and cut into landside slope without permission from CVFPB. See field investigation report for more detail.	37.427210 ° -120.999288 °	37.477210 ° -120.992880 °	Y	50
29	5.24	5.74	Earthen Levee	Vegetation	LS	M	Remove the wild growth other than native grasses from the levee slopes.	37.425587 ° -120.999820 °	37.420113 ° -120.999478 °		34
30	5.24	5.74	Earthen Levee	Vegetation	WS	M	Remove the wild growth other than native grasses from the levee slopes.	37.425587 ° -120.999820 °	37.420113 ° -120.999478 °		35

Levee Mile Report Line	28
Start Levee Mile	5.13
End Levee Mile	5.13
Location	
Category	Earthen Levee
Item	Encroachments
View of cut into landside slope

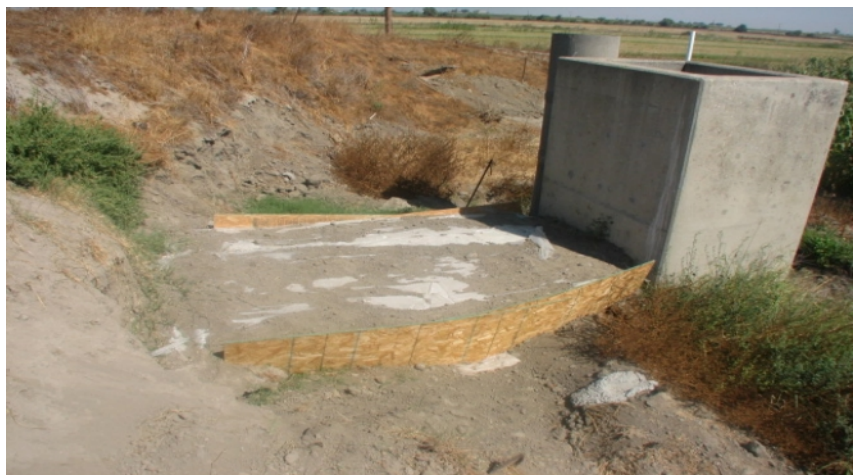
Levee Mile Report Line	28
Start Levee Mile	5.13
End Levee Mile	5.13
Location	
Category	Earthen Levee
Item	Encroachments
View of concrete stand pipe and encased pipe on landside toe.

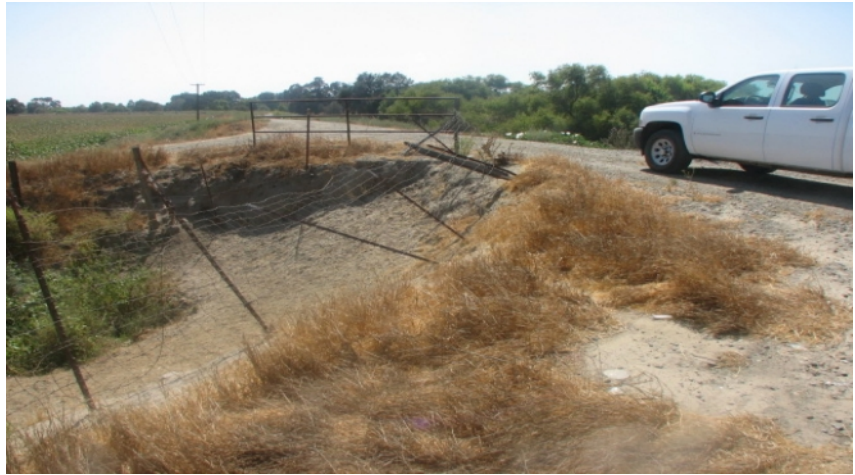
Levee Mile Report Line	35
Start Levee Mile	7.08
End Levee Mile	7.08
Location	
Category	Earthen Levee
Item	Slope Stability
Erosion located on landside slope above irrigation canal. Erosion cause by animal traffic

35	7.08	7.08	Earthen Levee	Slope Stability	LS	M	Repair slope instability.	37.409112 ° -120.992027 °	37.409112 ° -120.992027 °	Y	40
36	7.14	7.54	Earthen Levee	Vegetation	LS	M	Remove the wild growth other than native grasses from the levee slopes.	37.408208 ° -120.992045 °	37.404038 ° -120.987882 °		41
37	7.14	7.54	Earthen Levee	Vegetation	WS	M	Remove the wild growth other than native grasses from the levee slopes.	37.408208 ° -120.992045 °	37.404037 ° -120.987882 °		42
38	7.68	7.93	Earthen Levee	Vegetation	LS	M	Remove the wild growth other than native grasses from the levee slopes.	37.403518 ° -120.985883 °	37.401508 ° -120.982385 °		43
39	7.69	7.93	Earthen Levee	Vegetation	WS	M	Remove the wild growth other than native grasses from the levee slopes.	37.403498 ° -120.985862 °	37.401508 ° -120.982385 °		44
40	8.48	8.54	Earthen Levee	Vegetation	LS	M	Remove the wild growth other than native grasses from the levee slopes.	37.399187 ° -120.973865 °	37.398758 ° -120.973078 °		45
